# New York State Department of Transportation

## PIA Safety Flag NB23CTW011

**BIN: 1065318**

**Feature Carried: 278I278IX2M23027**

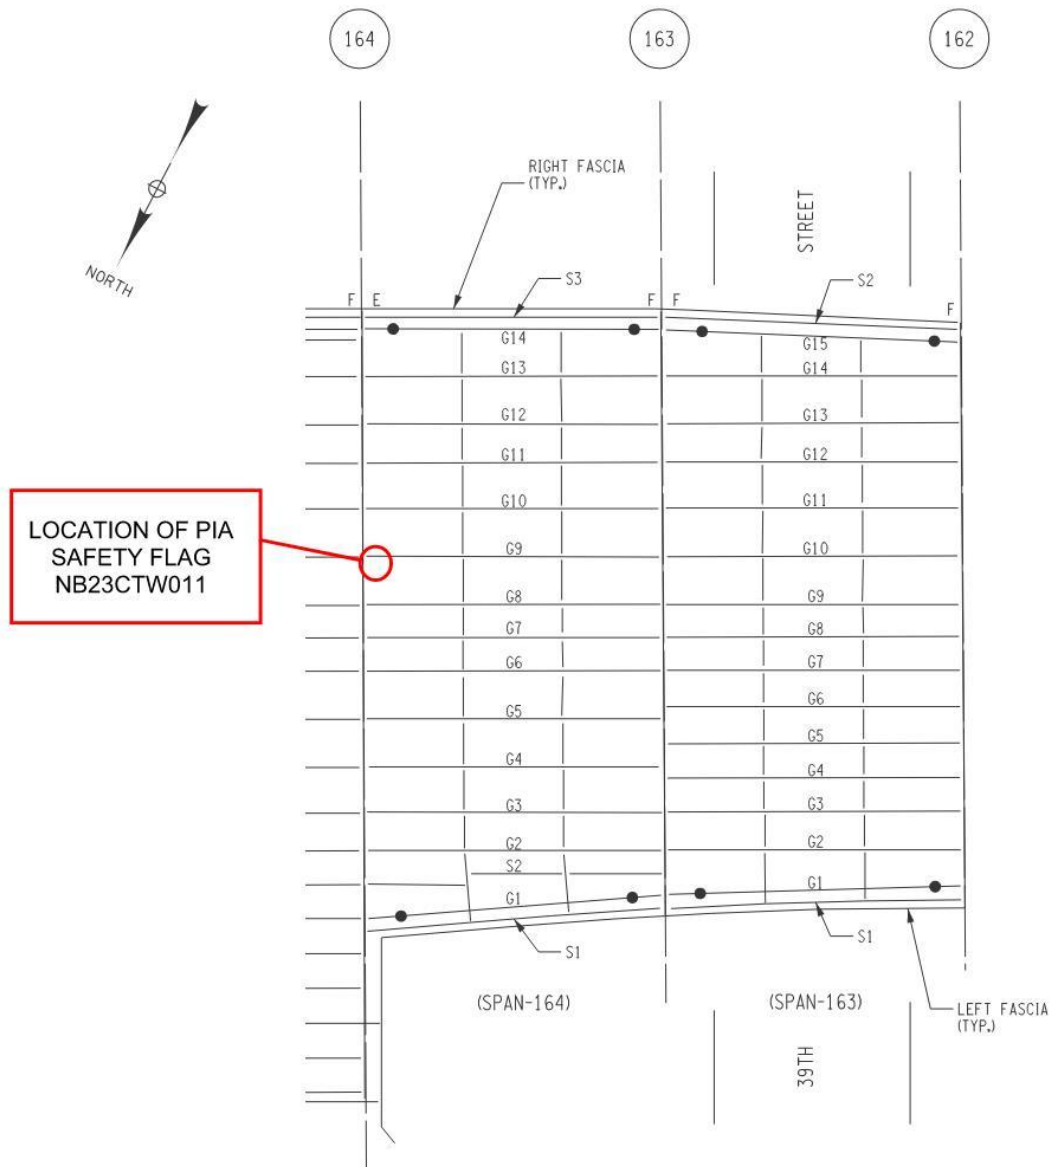
**Flag Photographs**Photo Number: **1**Photo Filename: **Flag Location - Span 164 RA.jpg**

Location: Span 164, Pier 164, near Column C3 at the base.

**Attachment Description: Flag Location Plan.**

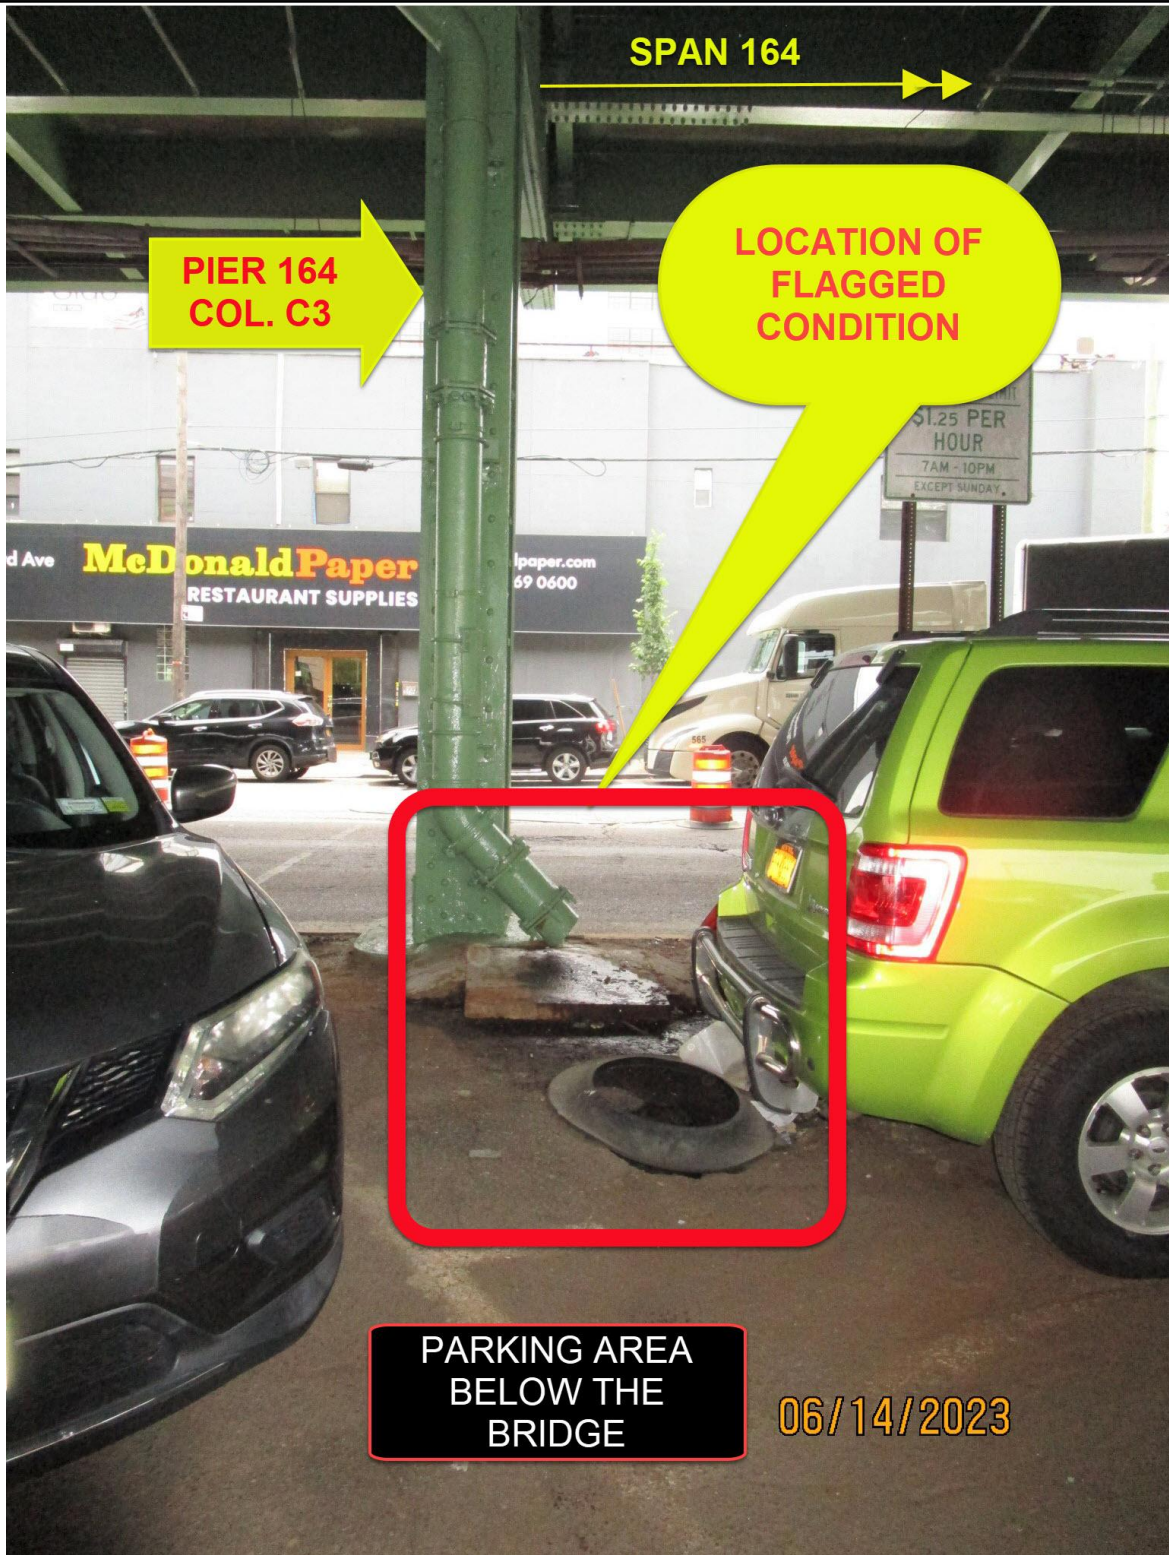
Photo Number: 2

**Attachment Description:** General view of the Flagged location. Looking Right.

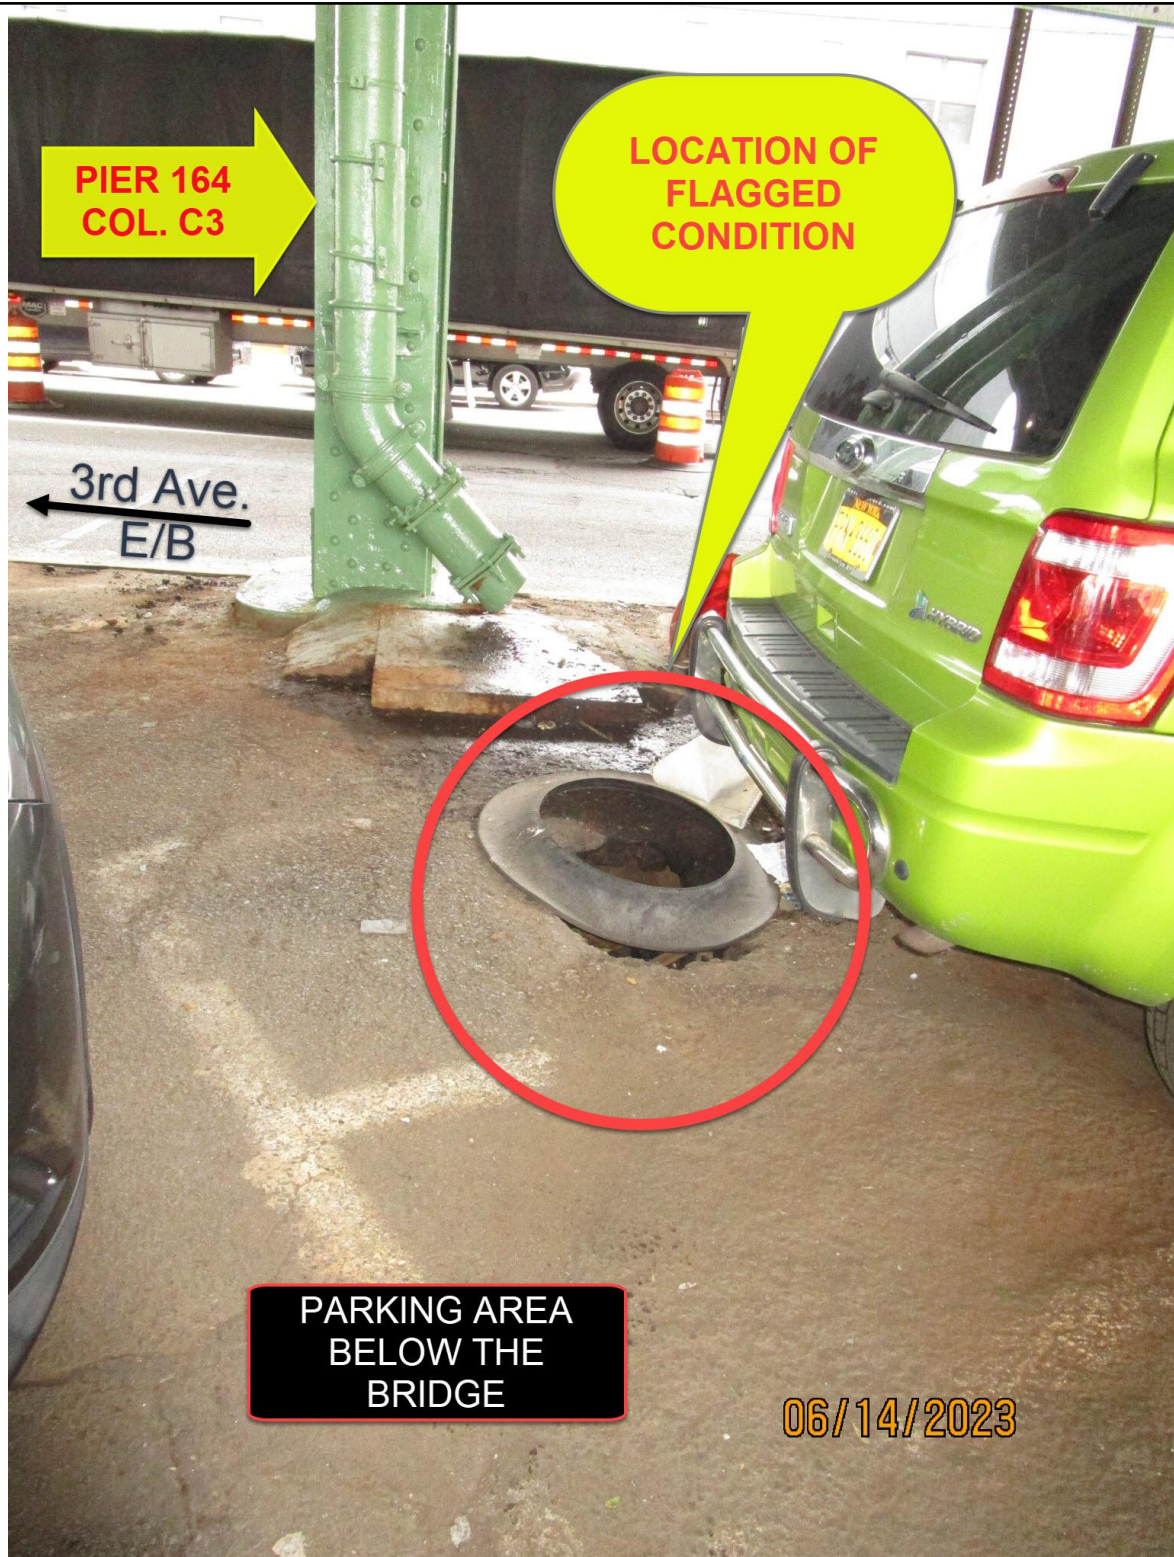
Photo Number: 3

At Span 164, Pier 164 approximately 6 feet from Column C3 base, there is a 3 ft. diameter erosion hole at the parking area pavement. The hole is approximately 1'-6" deep and is located within the area where cars are parked.

This condition poses hazard to the public accessing the parking area, hence warrants a PIA Safety Flag.

**Attachment Description:** A 3 ft. diameter erosion hole adjacent to Column C3. Looking Right.

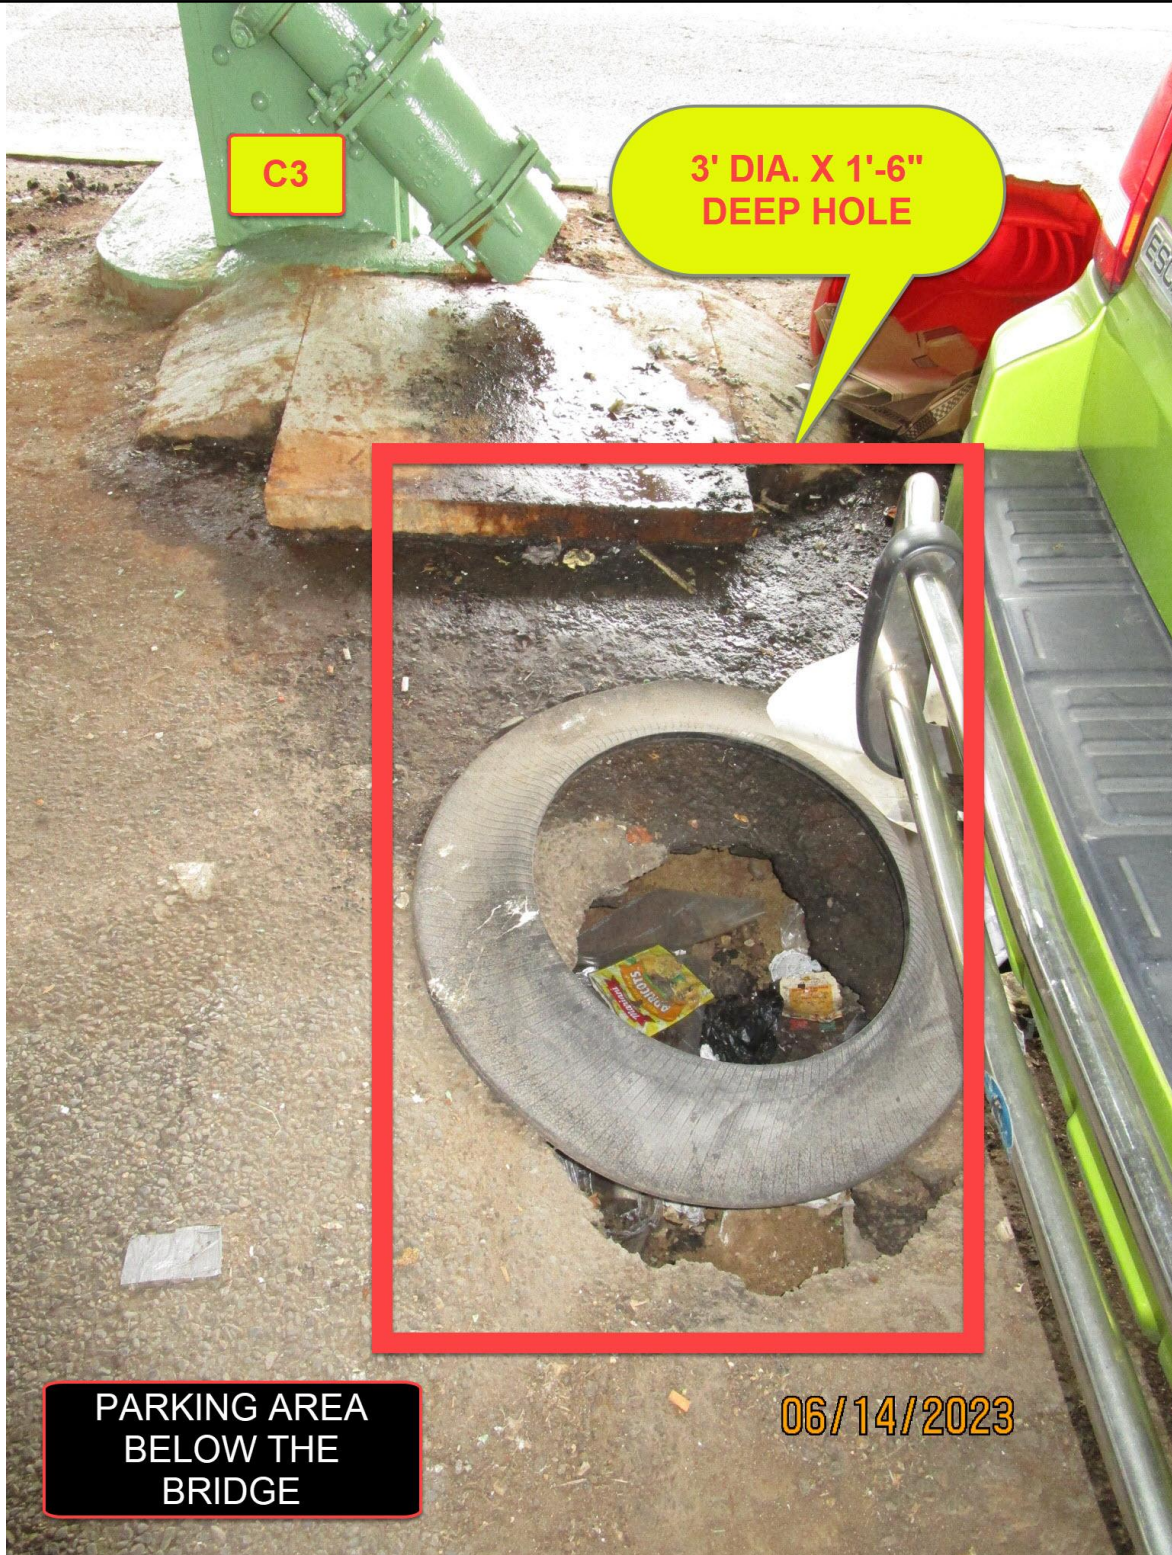
Photo Number: 4

**Attachment Description:** Close-up view of the erosion hole adjacent to Column C3. Looking Right.
